# Inspection Report

**Property Address:**  
123 Main St  
Brandon MS 39704

**Echols Home Inspections, LLC**

<b>Date:</b> 10/16/2012	<b>Time:</b> 12:45 PM	<b>Report ID:</b> debstealley
<b>Property:</b> 123 Main St Brandon MS 39704	<b>Customer:</b> Steve Alley	<b>Real Estate Professional:</b>

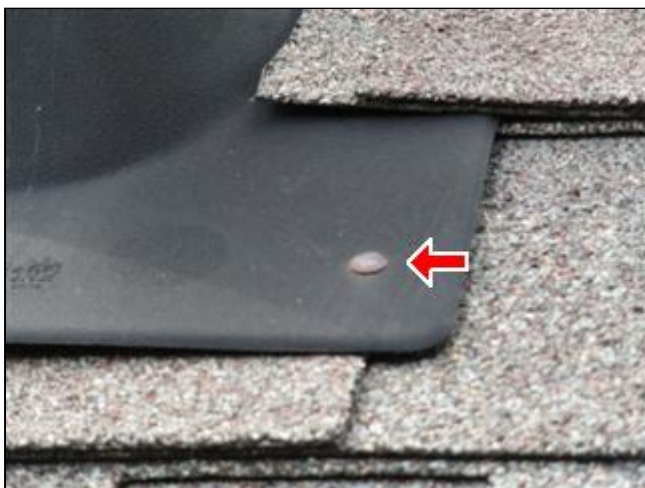
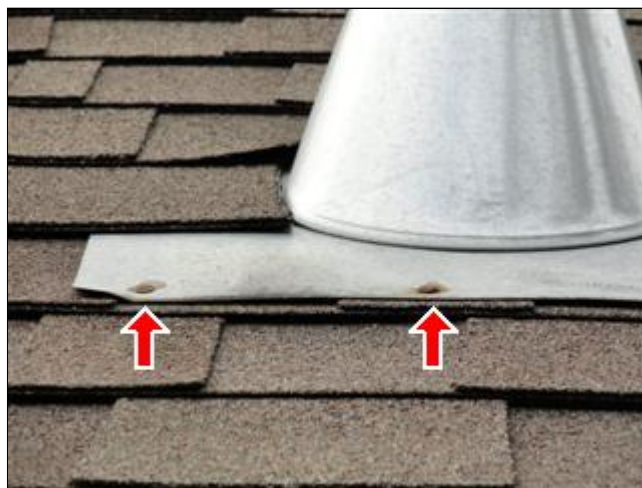
1.2 Picture 1

The nails for the flashings around the vent pipes and exhaust pipes need to be sealed to prevent moisture from entering the attic area.(Picture 1) (Picture 2)

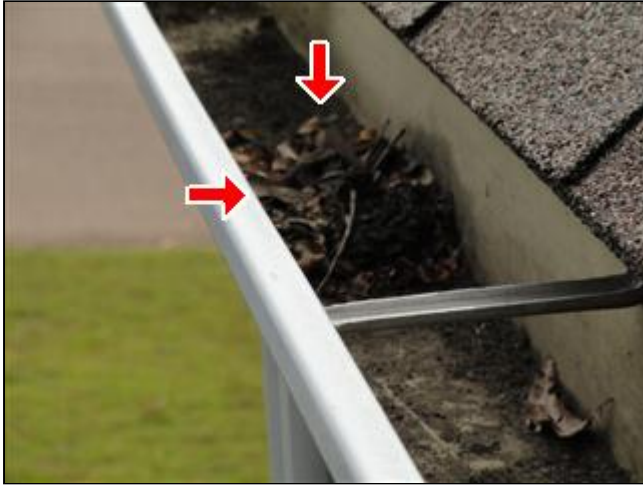
1.3 Picture 1

The gutters are full of debris in areas around the downspouts and needs to be cleaned. The debris in gutters can also conceal rust, deterioration or leaks that are not visible until cleaned, and I am unable to determine if such conditions exist. This is a maintenance issue.(Picture 1)

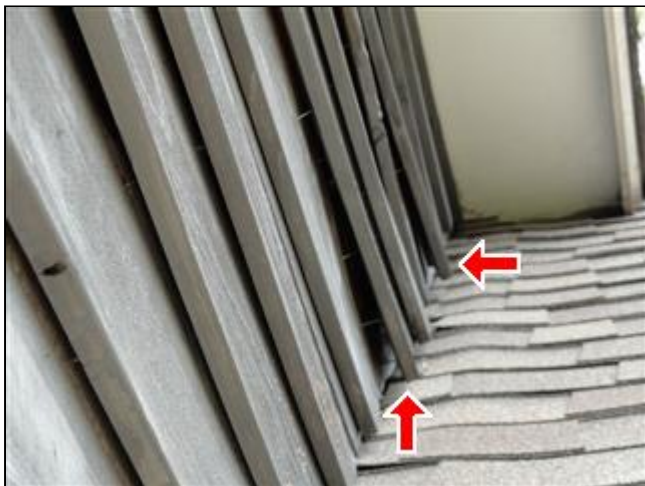
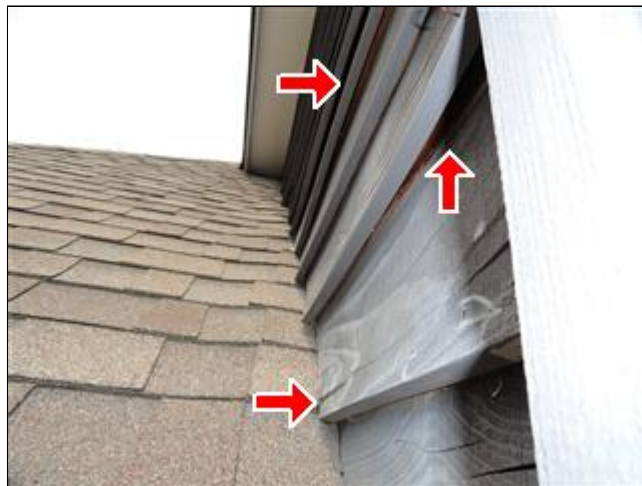
2.0 Picture 1

The brick veneer siding appears in satisfactory condition. The wood siding on the Dormer at the front of the house appears to be pulling away from the sheathing and is cracking and warping. This was observed from a ladder and with binoculars because of the pitch of the roof. (Picture 1) (Picture 2)

The brick veneer siding appears in satisfactory condition. The wood siding on the Dormer at the front of the house appears to be pulling away from the sheathing and is cracking and warping. This was observed from a ladder and with binoculars because of the pitch of the roof. (Picture 1) (Picture 2)

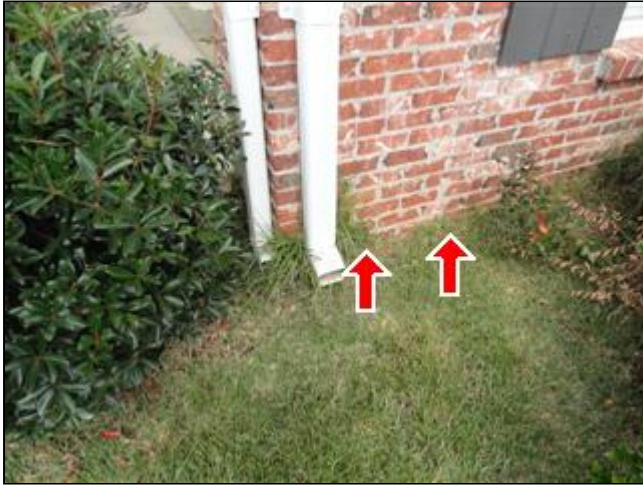
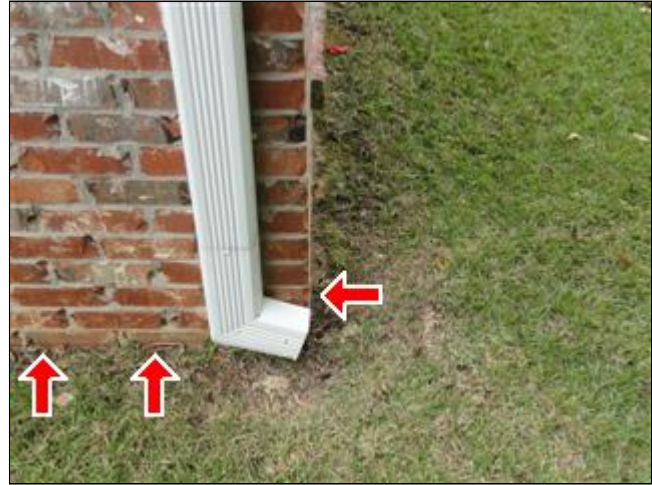
2.4 Picture 1

The brick veneer siding around the entire house is below soil level: Recommend grading soil so there's at least 4" of space (where practical) between the brick and the soil below and replacing any rotten trim and siding materials that may be found.(Picture 1) (Picture 2)

The brick veneer siding around the entire house is below soil level: Recommend grading soil so there's at least 4" of space (where practical) between the brick and the soil below and replacing any rotten trim and siding materials that may be found.(Picture 1) (Picture 2)

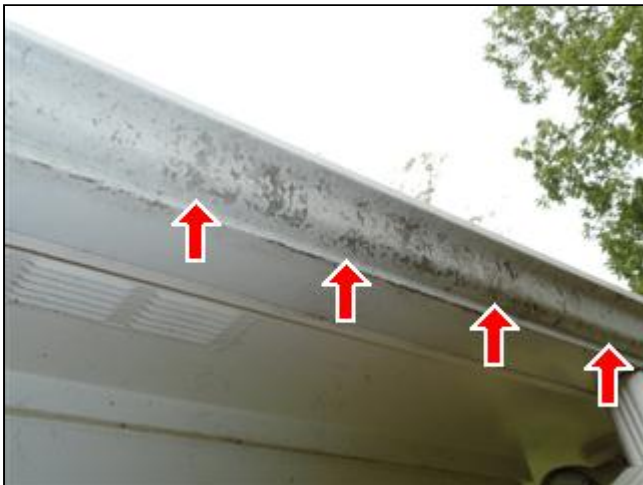
2.5 Picture 1

The Soffit and Fascia boards along the left and right sides of the house showed signs of fungal growth and need routine cleaning with a bleach type product.(Picture 1)

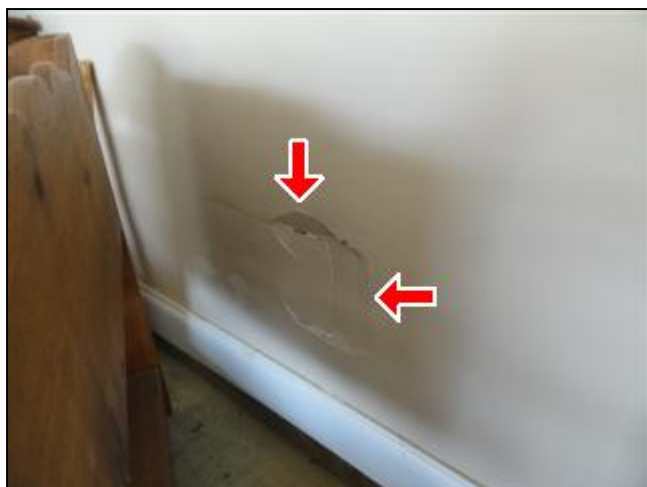
3.1 Picture 1

There is sheetrock damage to the rear of the garage. Recommend repair.(Picture 1)

There is sheetrock damage to the rear of the garage. Recommend repair.(Picture 1)

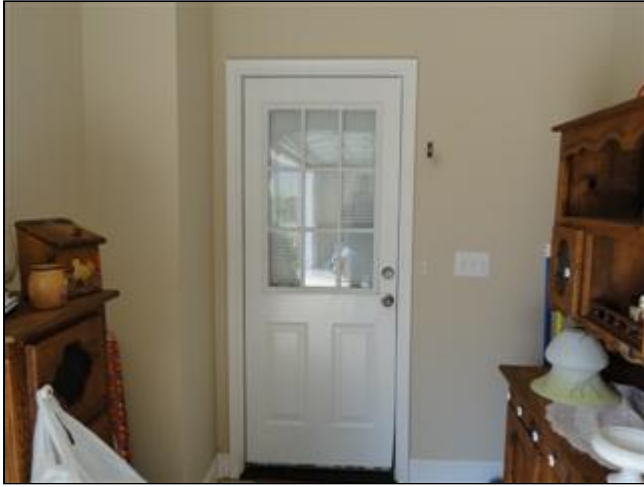
3.4 Picture 1

The occupant door from inside garage to inside the home is not a fire rated door. This means that should a fire occur in garage, the occupant door does not afford protection until fireman arrive. This door should be replaced with a fire rated door.(Picture 1)

The occupant door from inside garage to inside the home is not a fire rated door. This means that should a fire occur in garage, the occupant door does not afford protection until fireman arrive. This door should be replaced with a fire rated door.(Picture 1)

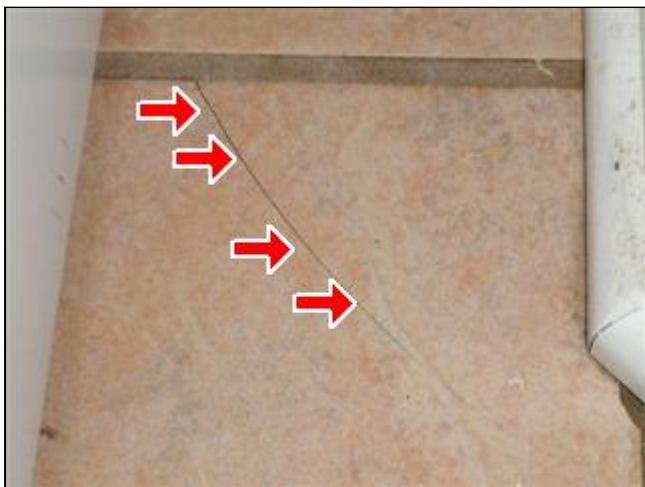
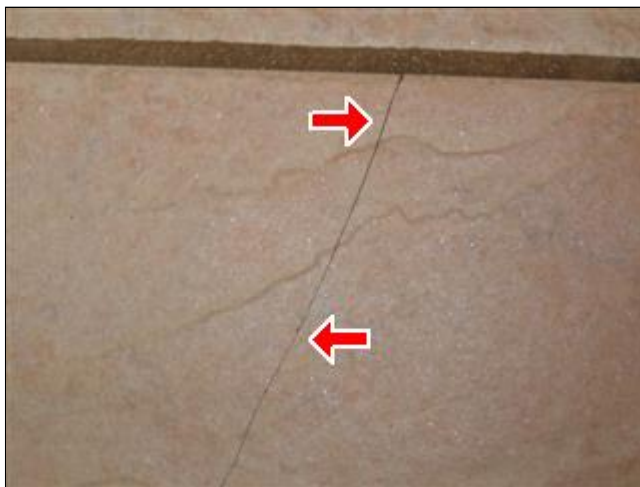
4.2 Picture 1

The tile floor in the kitchen and laundry area has some cracked and loose tiles. This is likely from poor installation. Recommend repair by licensed contractor.

The tile floor in the kitchen and laundry area has some cracked and loose tiles. This is likely from poor installation. Recommend repair by licensed contractor.

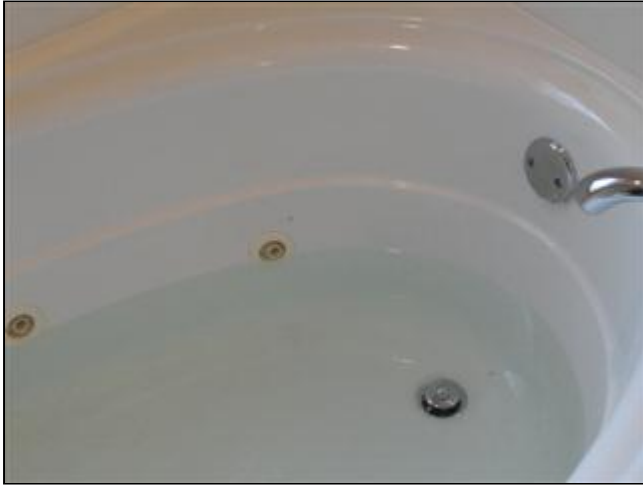
4.7 Picture 1

The whirlpool tub in the Master bathroom was tested and was not operable at the time of the inspection. I could not find an access panel to gain access for electrical and plumbing. Recommend repair as needed.(Picture 1)

The whirlpool tub in the Master bathroom was tested and was not operable at the time of the inspection. I could not find an access panel to gain access for electrical and plumbing. Recommend repair as needed.(Picture 1)

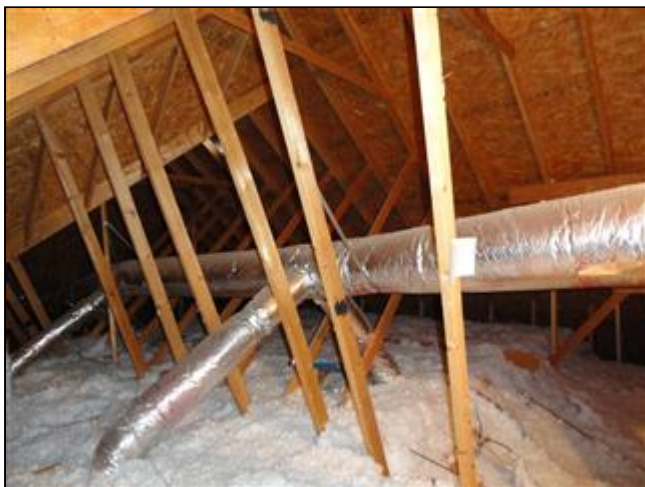
(1) The attic was inspected by walking the attic.(Picture 1)

5.5 Picture 1 Attic view

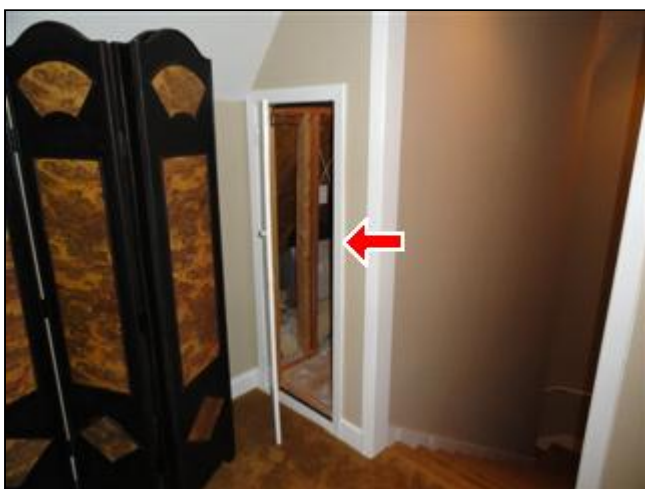
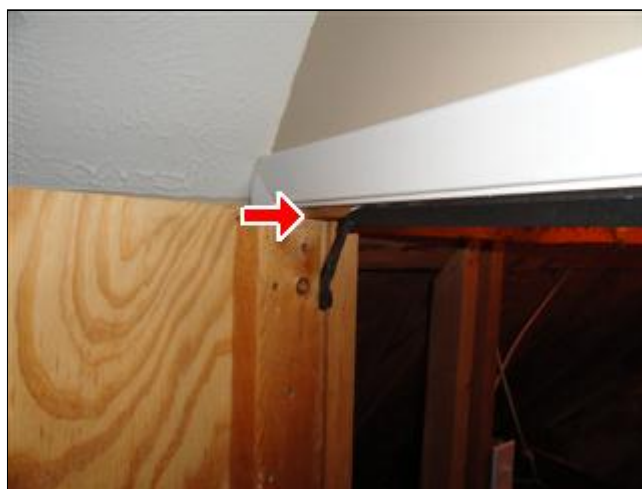
5.5 Picture 2

(2) The attic access door should have a latching system to ensure a weatherproof seal between the attic and the living space. This door is held closed by a screw. This is inadequate and needs to be repaired.(Picture 2)

The weather-stripping for the attic access door is deteriorating and needs repairing or replacement.

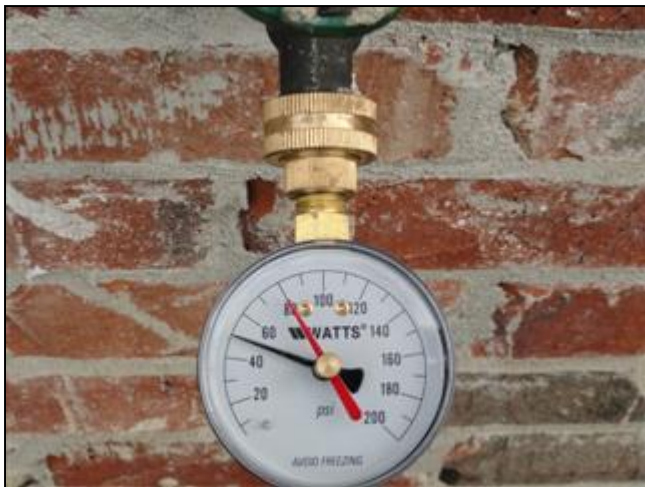
(1) The water pressure was tested at the hose bib on the left side of the house. The pressure tested at 50 psi (pounds per square inch). This is adequate.(Picture 1)

6.1 Picture 1 50 psi

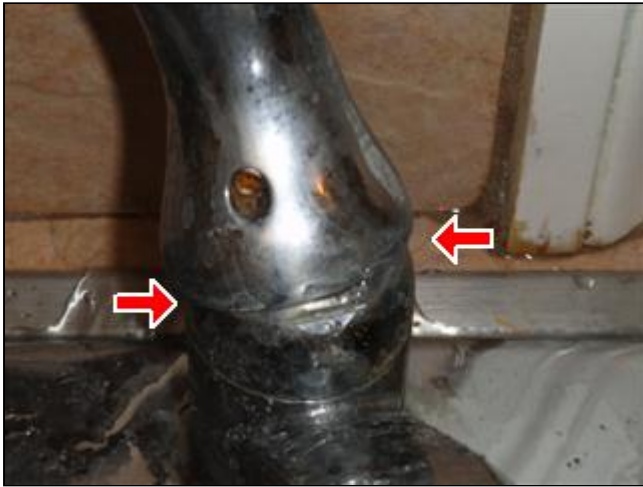
6.1 Picture 2

(2) The fixture at the kitchen sink leaks onto the sink and tile area from the handle. Recommend licensed plumber to repair or replace.(Picture 2)

(2) The fixture at the kitchen sink leaks onto the sink and tile area from the handle. Recommend licensed plumber to repair or replace.(Picture 2)

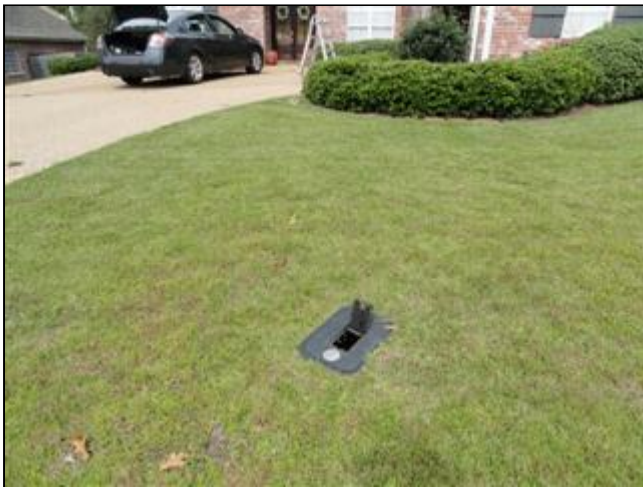
(1) The main shut off is located outside in the ground to the right of the driveway.(Picture 1)

6.3 Picture 1 Main water shut off

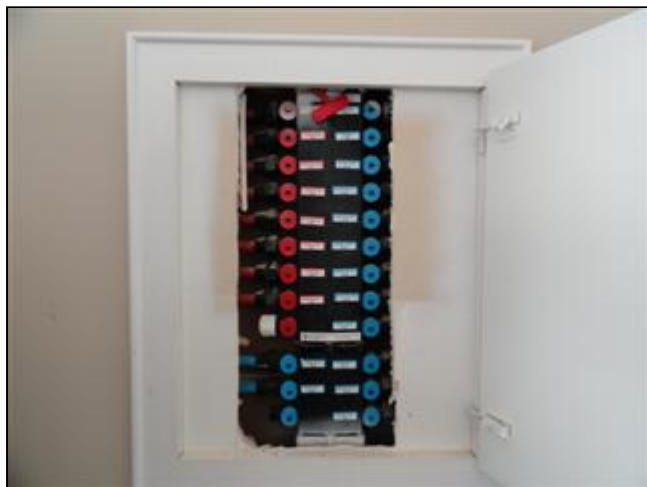
(2) There is a water manifold located in the garage. This is a feature to be used to shut water off to individual areas of the home as needed.(Picture 2)

6.3 Picture 2 Water manifold in garage

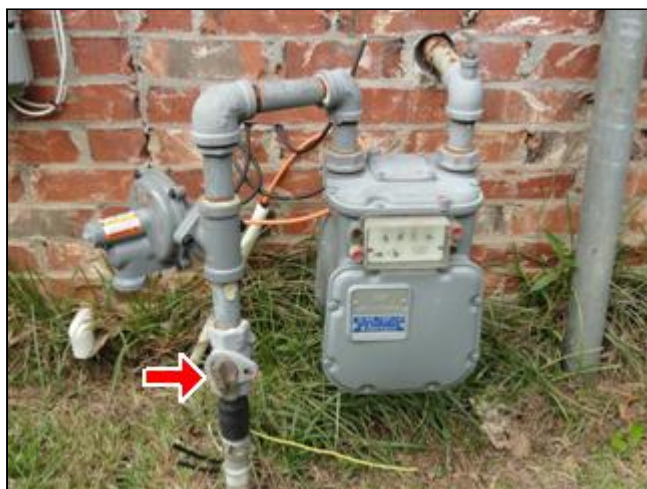
The main shut off for the gas is located on the right side of the house.(Picture 1)

6.5 Picture 1 Main gas shut off

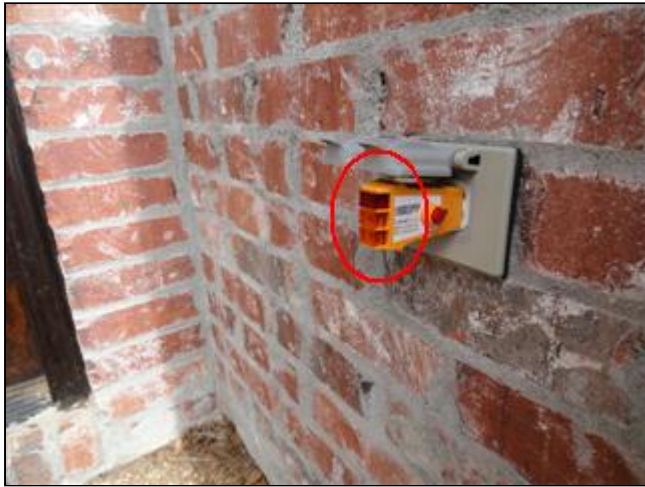
7.4 Picture 1

All exterior outlets were inoperable at the time of the inspection. This could be from the GFCI outlet located on the front exterior wall of the garage. This outlet was inoperable. Recommend licensed electrician to evaluate and repair.

All exterior outlets were inoperable at the time of the inspection. This could be from the GFCI outlet located on the front exterior wall of the garage. This outlet was inoperable. Recommend licensed electrician to evaluate and repair.

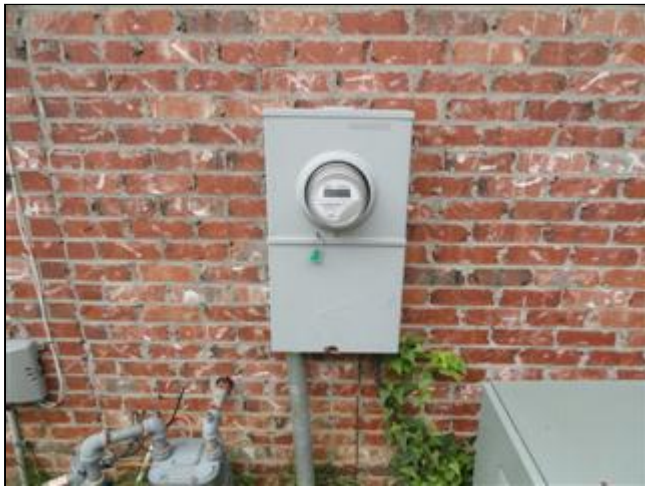
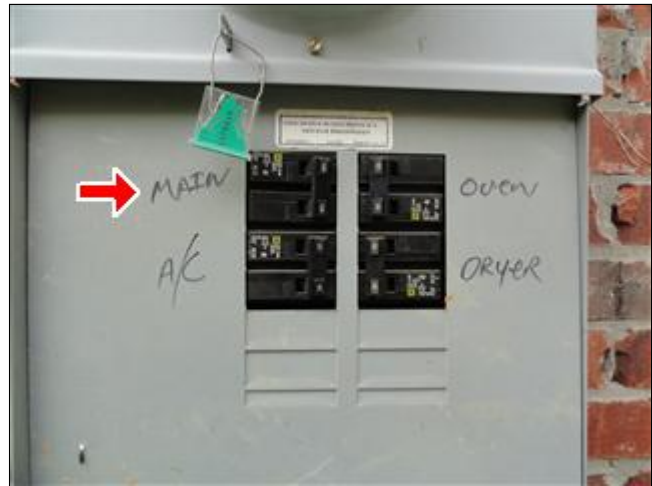
(1) The main panel box is located at the exterior right side of the house.(Picture 1) The main shut off for the house is located in this panel. (Picture 2)

7.6 Picture 1 Main Panel

7.6 Picture 2 Main Shut Off Switch

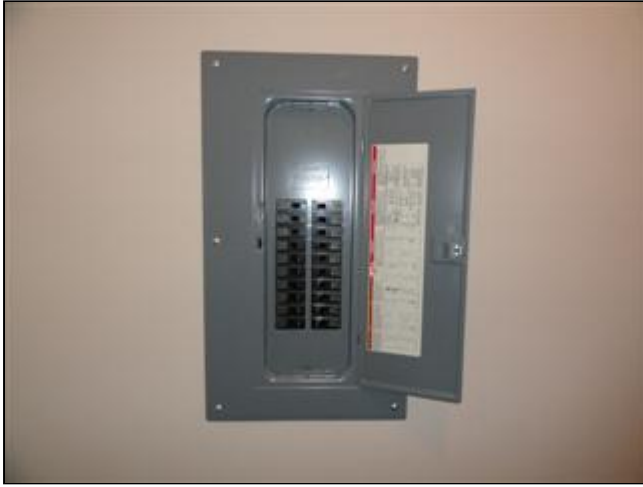
(2) The Sub Panel is located in the laundry room.(Picture 3)

7.6 Picture 3 Sub Panel

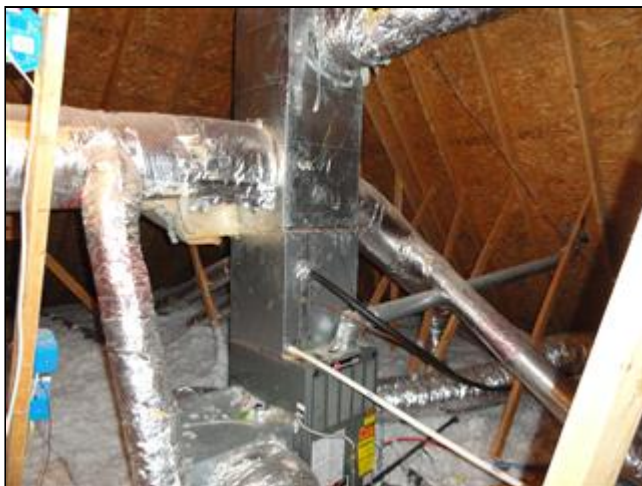
(2) The Heating unit was also manufactured in 2003.(Picture 2)

8.11 Picture 2 Furnace in attic

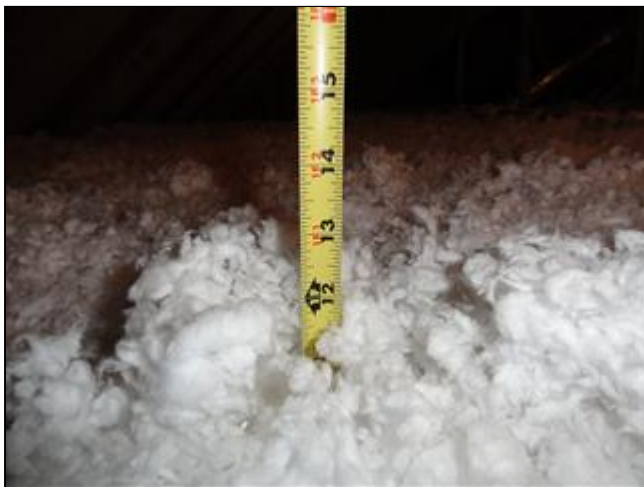
(1) The blown fiberglass insulation had varied degrees of thickness which is a normal application. This is approximately an R-30 rating which is adequate.

9.0 Picture 1 Blown attic insulation

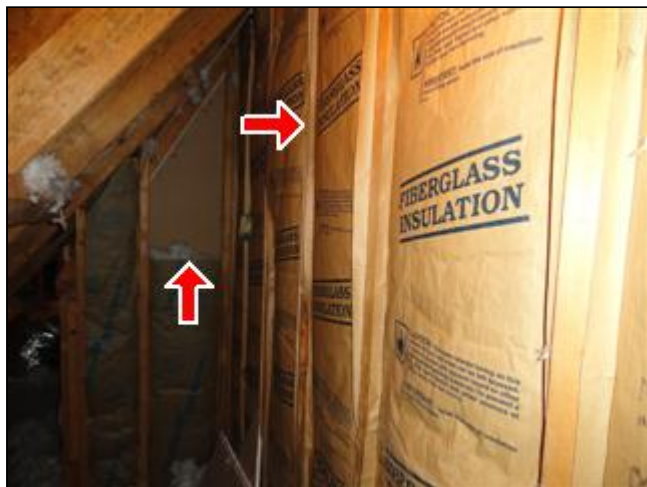
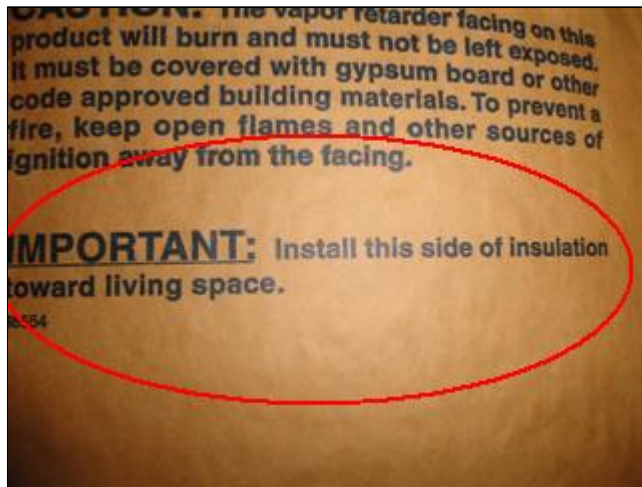
9.0 Picture 3

(2) The insulation surrounding the upstairs bonus room has the vapor barrier installed backwards around the entire upstairs room and there is some missing insulation. This can limit the insulating value of the insulation for the living space of the room.(Picture 2) (Picture 3)

9.0 Picture 2 Vapor Barrier installed backwards and missing

(2) The insulation surrounding the upstairs bonus room has the vapor barrier installed backwards around the entire upstairs room and there is some missing insulation. This can limit the insulating value of the insulation for the living space of the room.(Picture 2) (Picture 3)

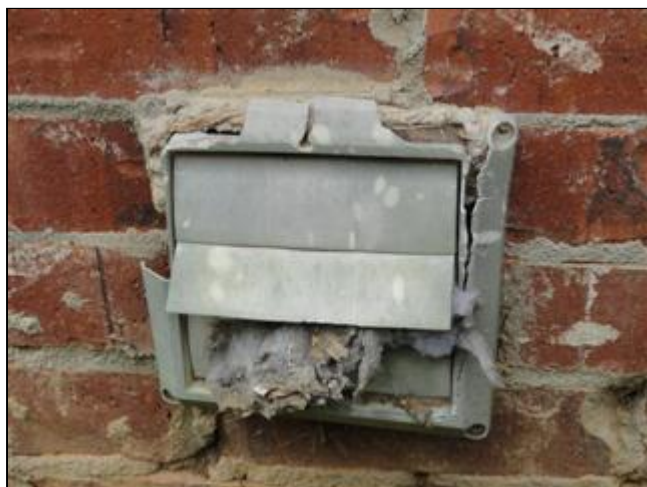
9.4 Picture 1

The dryer vent piping is clogged at the exterior of the house and the vented plastic cover is damaged. I recommend repair as needed.
